A Study of
Cape Horn Construction
on the Central Pacific Railroad
1865-1866

by
Jack E. Duncan

Summary of the Study

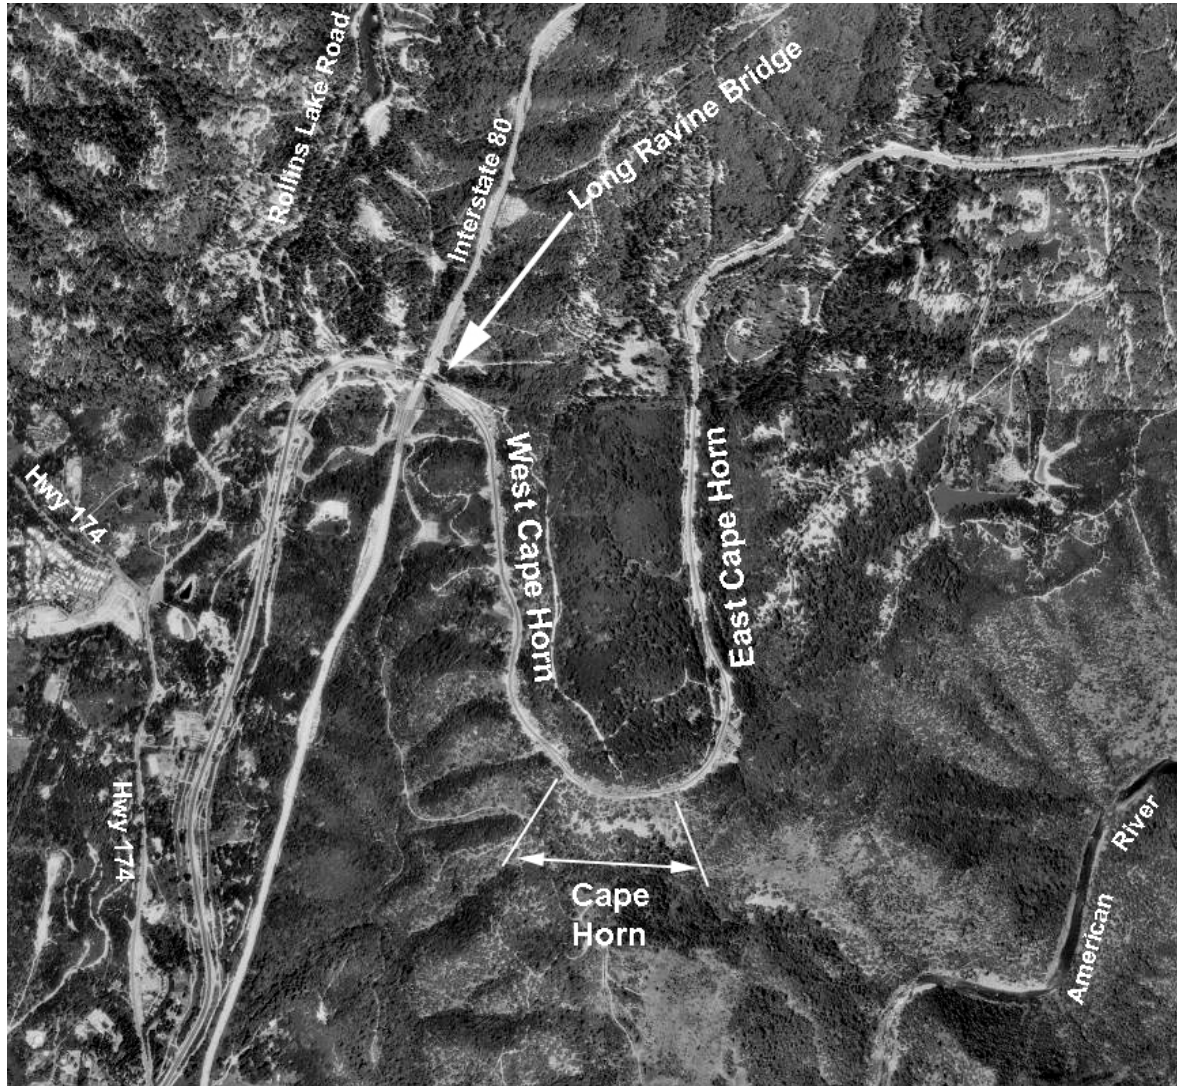
Figure 2 USGS aerial photo of Cape Horn area

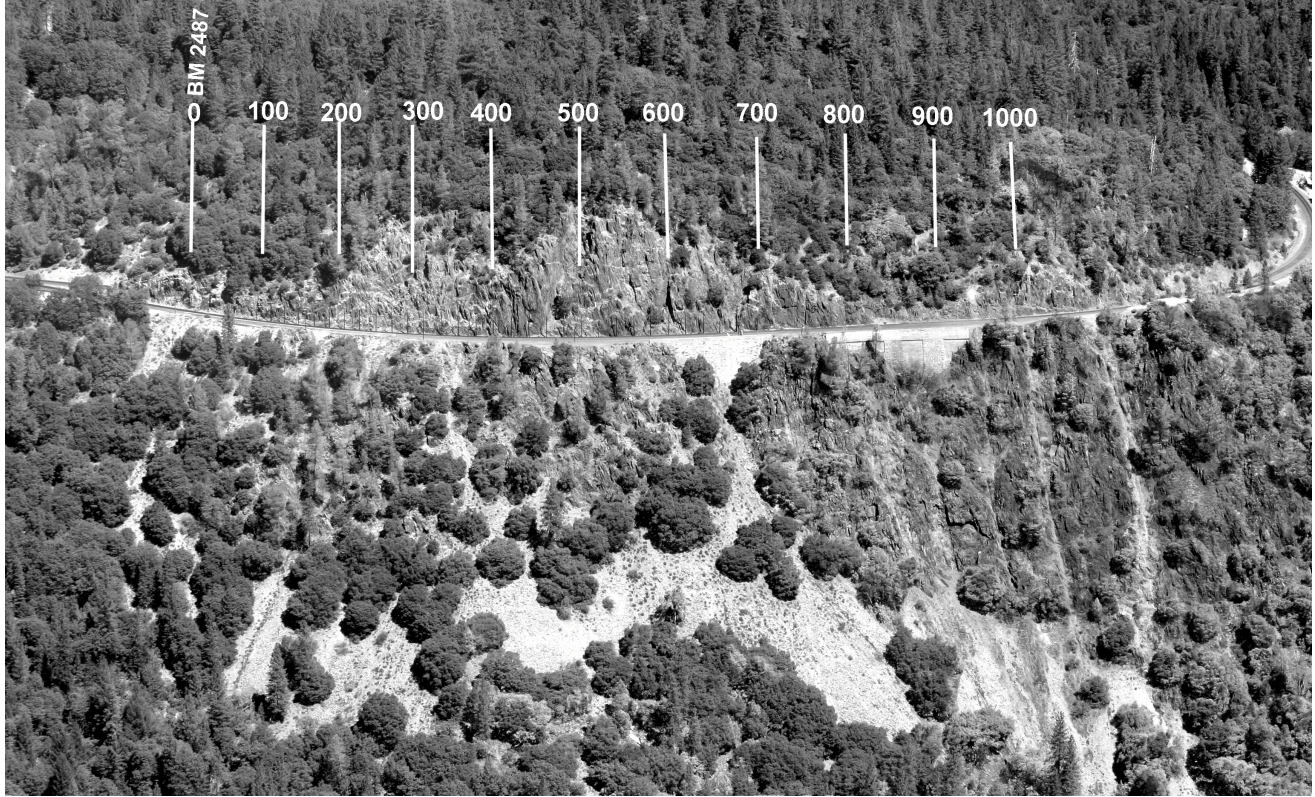
Figure 1 Above is an aerial photograph taken in 2004 of the section of railroad near Colfax, California known as Cape Horn. This study focuses on the 1000-foot section of Central Pacific Railroad indicated by the numbers on the photograph.

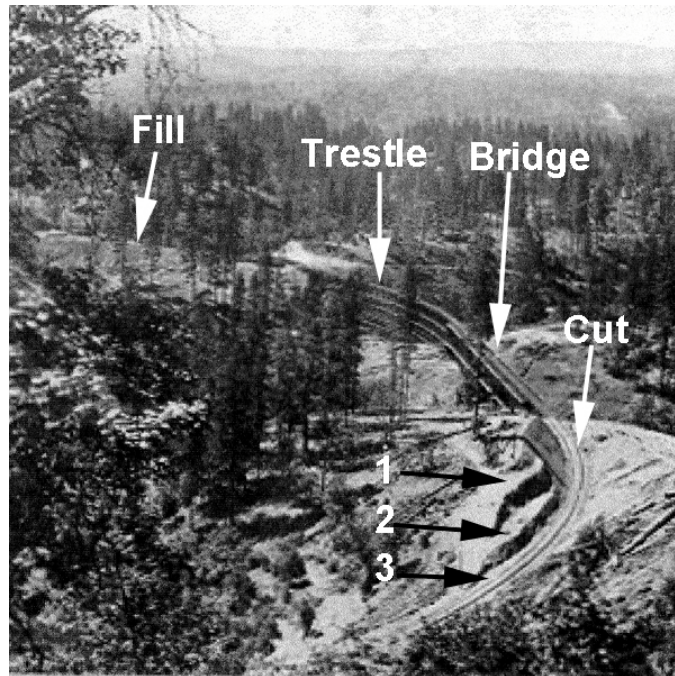
Figure 18 Choosing the best elevation for crossing Long Ravine Gap required compromising on the fill/trestle/bridge/cut as shown. The three cart roads that were used in 1865 are visible in the cut.

Construction Survey This section examines the reasons for locating the track bed at the 2500 feet elevation instead of locating it either higher or lower. The two gaps, Long Ravine and Secret Town, dictated the elevation at Cape Horn. Higher would have been easier while lower would have been far more difficult.

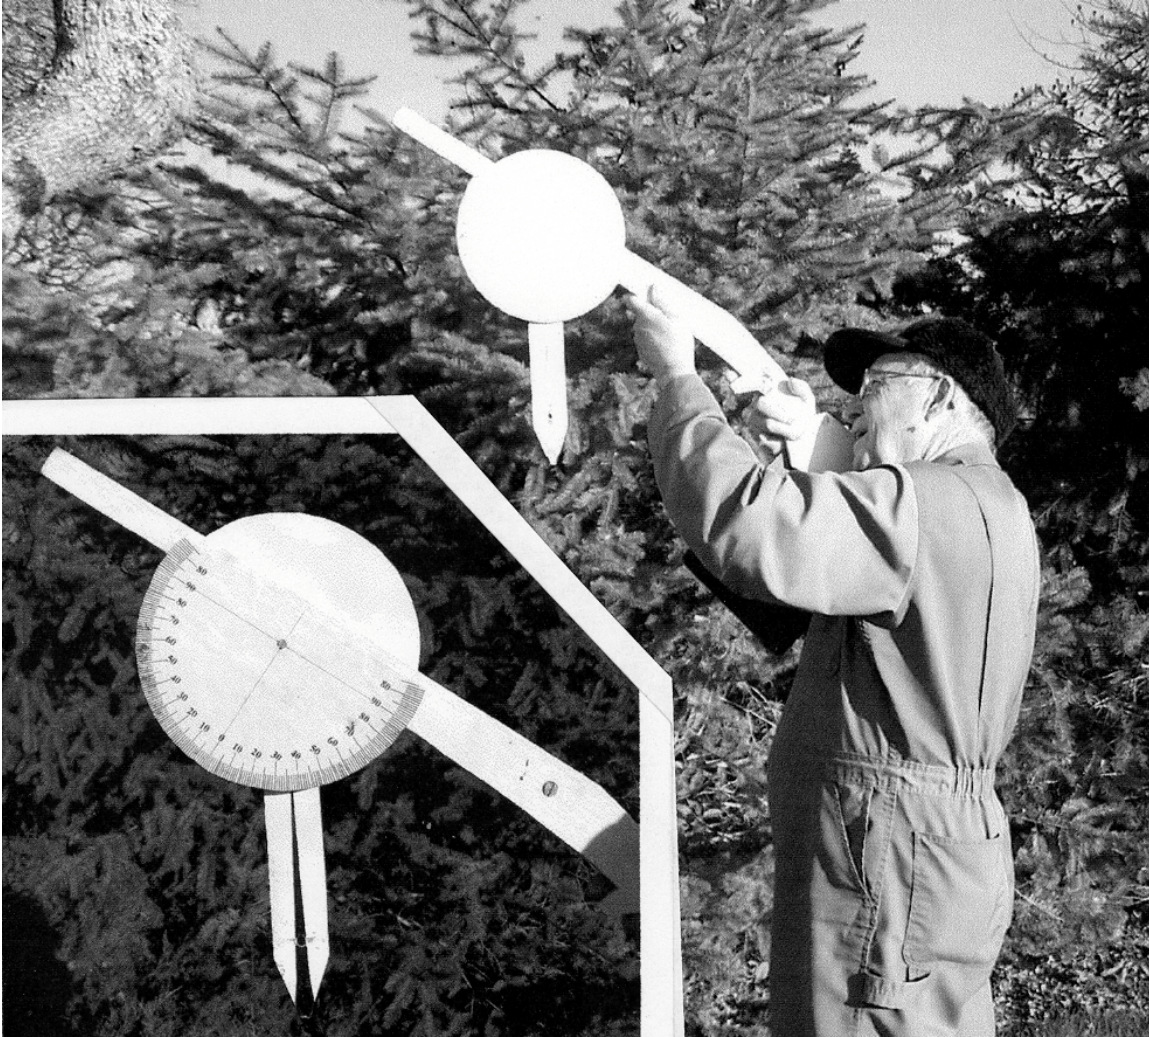
Figure 32 Slope gauge with weighted pointer reads 36 degrees. While using surveyor's equipment could make more precise measurements, this simple tool easily measured within 1 degree, which is adequate for this study.

Cape Horn Appearance in 2004 About 140 slope measurements were recorded along the 1000 foot Cape Horn in 2004 using the *slope gauge* shown in Figure 32. This convenient tool was used along the roadbed, also above and below the roadbed. Using these slope figures, cross sections of the existing cut were drawn at each 100-foot station. The reader can develop an excellent idea of the volume of rock that has been cut along this hillside by examining these cross sections. The vast majority of this excavation occurred in 1929, not in 1865.

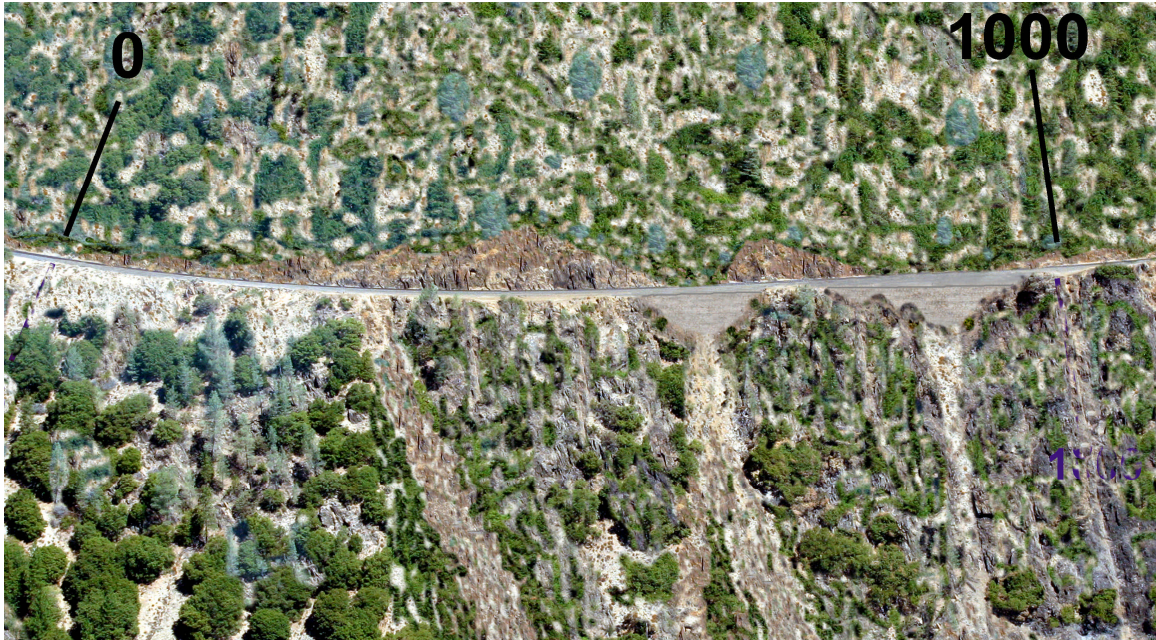
Figure 51 Cape Horn in 1866 after completion of construction.

The procedure used for developing the cross sections used drawings and photos from the 1860s and early 1870s. The results of this *back engineering* procedure are shown in Figure 51. Modifying the 2004 Figure 52 developed this figure. The purpose of Figure 51 is to show the small early cut compared to the present large cut. Brush and tree coverage is of course artificial but it is intended to indicate rather sparse cover as determined from many photos in the 1870s.

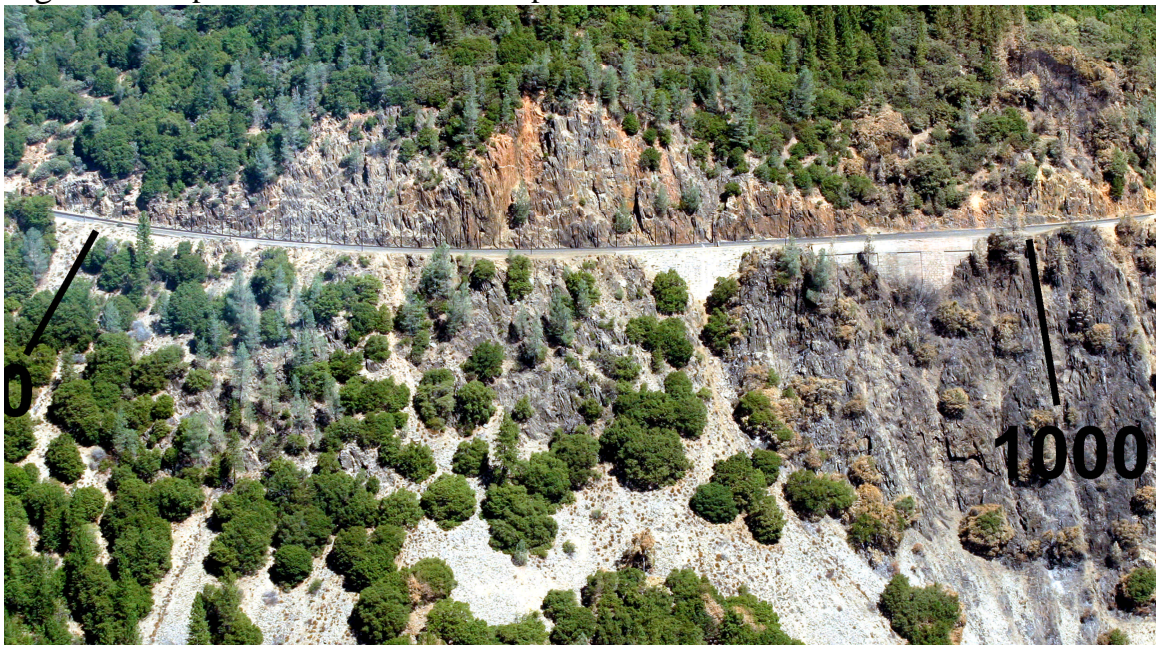
Figure 52 Cape Horn in 2004. Most of the additional cutting and some retaining wall improvements occurred in 1929. After 16 years of abandonment (1913-1929) this roadbed was improved allowing the eastbound, uphill traffic to be removed from Tunnels 33 and 34, and returned to this original 1866 location.
